Information about the schools proposed to renovation by “AEF” in 2008

Region Nagorno Karabagh Martuni, village Qarahunj

Estimate of construction works of the secondary school in the Qarahunj village in Nagorno Karabagh Martuni region

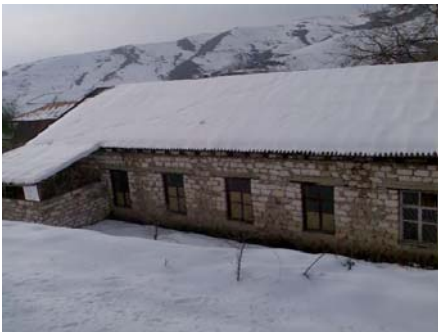
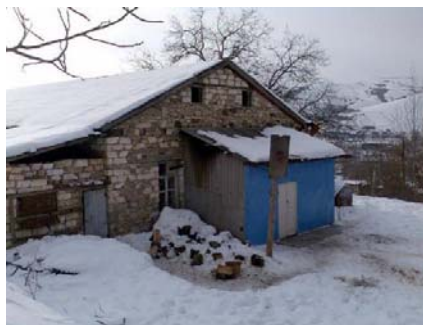
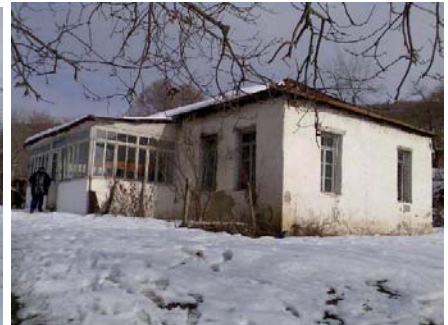
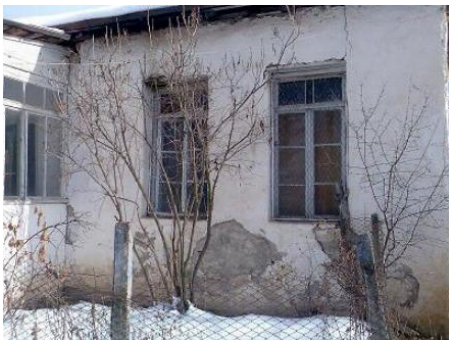
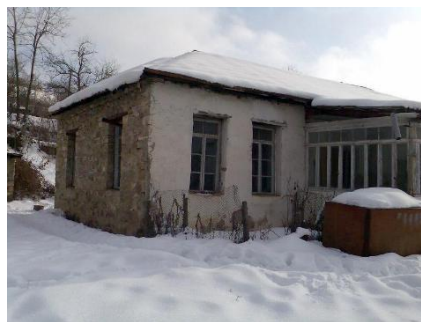
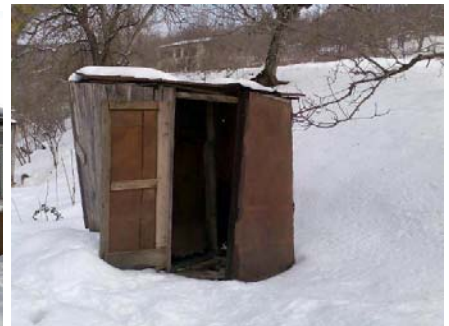
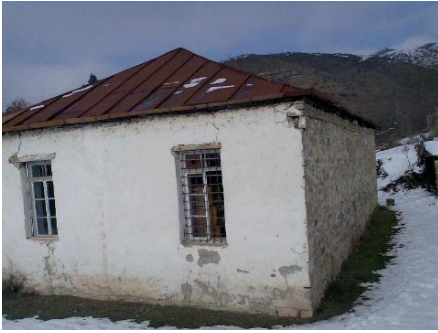
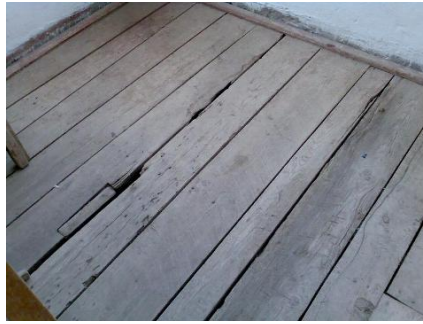
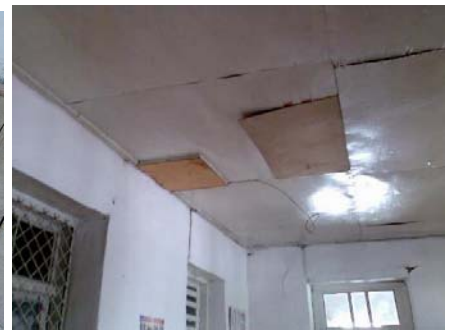
4. The school consists of 2 buildings. The school is one-storied.
5. Our suggestion was to renovate the whole school.
6. The roof is covered with asbestos sheeting and is intended to be entirely changed with metal tin. The second building's roof is from tin and needs being repaired.

7. The school's electricity in bad state and will be repaired.
8. The school is heated with stoves (with wood). Further it will be heated with electricity.

9. The floors are intended for being partly repaired and partly changed.
10. The toilets are outdoors and must be repaired. No water around the school.
11. The doors will be repairing, and some will be changed.

12. The windows are intended to be entirely renovated.
13. The school will be plastered and corrected from indoors and outdoors
14. The school was built in 1960.

To my mind the school must be immediately renovated. The school headmaster is Mr. Arthur Lalayan. To my mind after the renovation it will be normally kept.
